RCRA Corrective Action Order Compliance Report

**Facility Name:** Former Rhone Poulenc Facility  
**Facility EPA ID#:** WAD 009282 2302  
**Facility Location:** 9229 East Marginal Way  
Seattle, WA  
**Facility Representatives:** John Ambrose, RCI Environmental  
Tasha Grey, Geomatrix  
Sarah Ruston, Geomatrix  
**Date of Inspection:** August 17, 2004  
**Date of Report:** September 9, 2004  
**Report Prepared by:** Shawn Blocker, *shwblck 9/19/04*  
**Inspector(s):** Shawn Blocker, Environmental Scientist  
US Environmental Protection Agency  
1200 Sixth Avenue, WCM-126  
Seattle, WA 98101

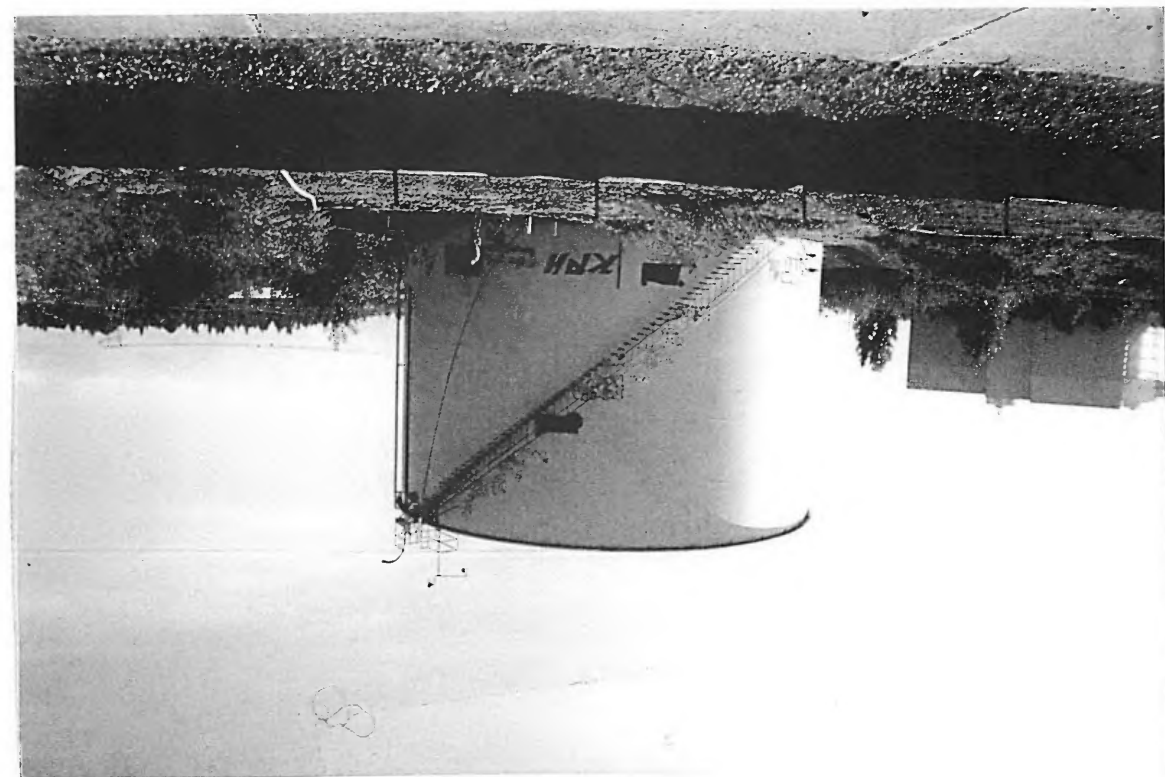
At this time I noticed 4 inch PVC piping on the ground near the large above ground storage tank located on site (photo 1). Upon further inspection, I found two different PVC lines originating from the tank. One line ("Line 1") was connected to a flex hose that went up the side of the tank completely to the top (photo 2 through 4). Line 1 proceeded from the tank in a northwestern direction across a containment berm, at which time it angled 45 degrees and ran directly east into the King County Sewer Lift Station (photo 5 and 6). I observed another portion of missing fence adjacent the lift station (photo 13). The other line ("Line 2") proceeded from near the bottom the tank directly north then turned 90 degrees terminating near the berm. After inspecting Line 2, I proceeded up the stairwell of the tank to the top. At the top, I observed that the flex line associated with Line 1 proceeded down into the tank and into several feet of liquid contained within the tank (photo 7 through 9). The hose was hooked to a submersible pump (photo 9). After observing this I proceeded down the stairs toward the access gate adjacent the Duwamish waterway.

1. Above ground storage tank.

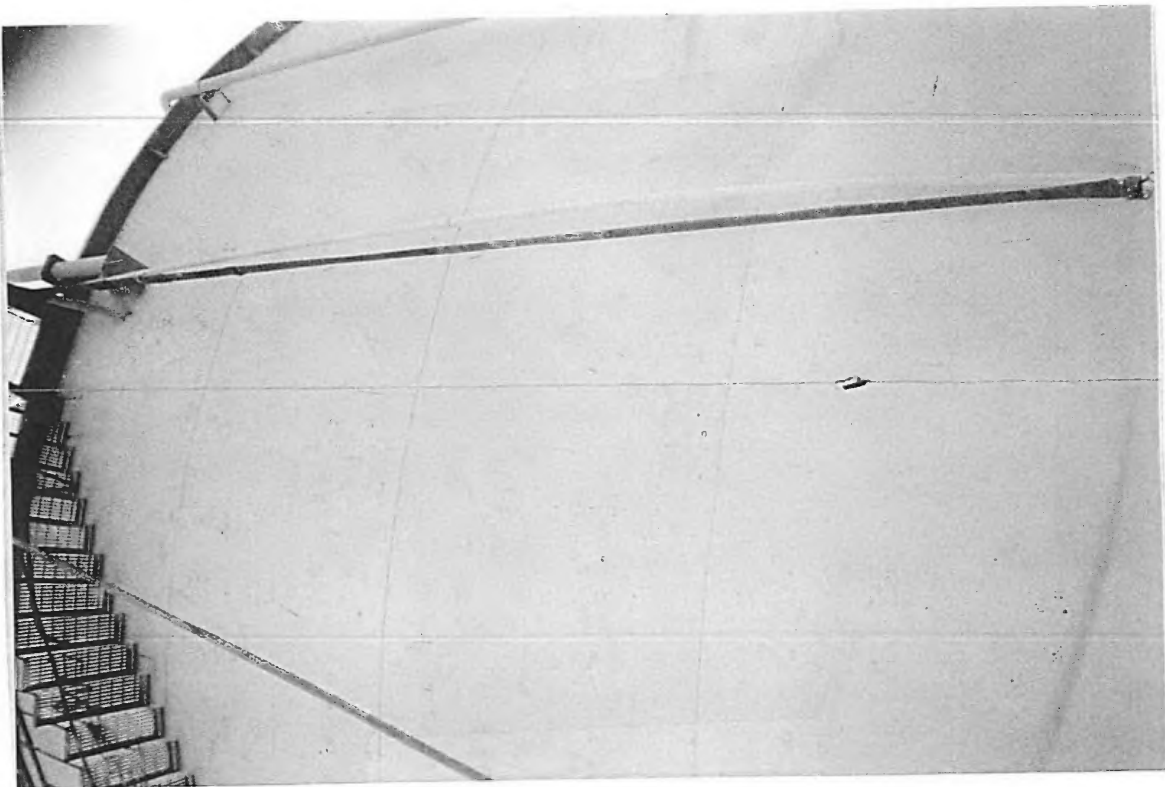
Photo 2. Flexhouse going up and into above ground storage tank.  
Photo taken by Shawn Blocker, U.S. EPA  
8/17/2004

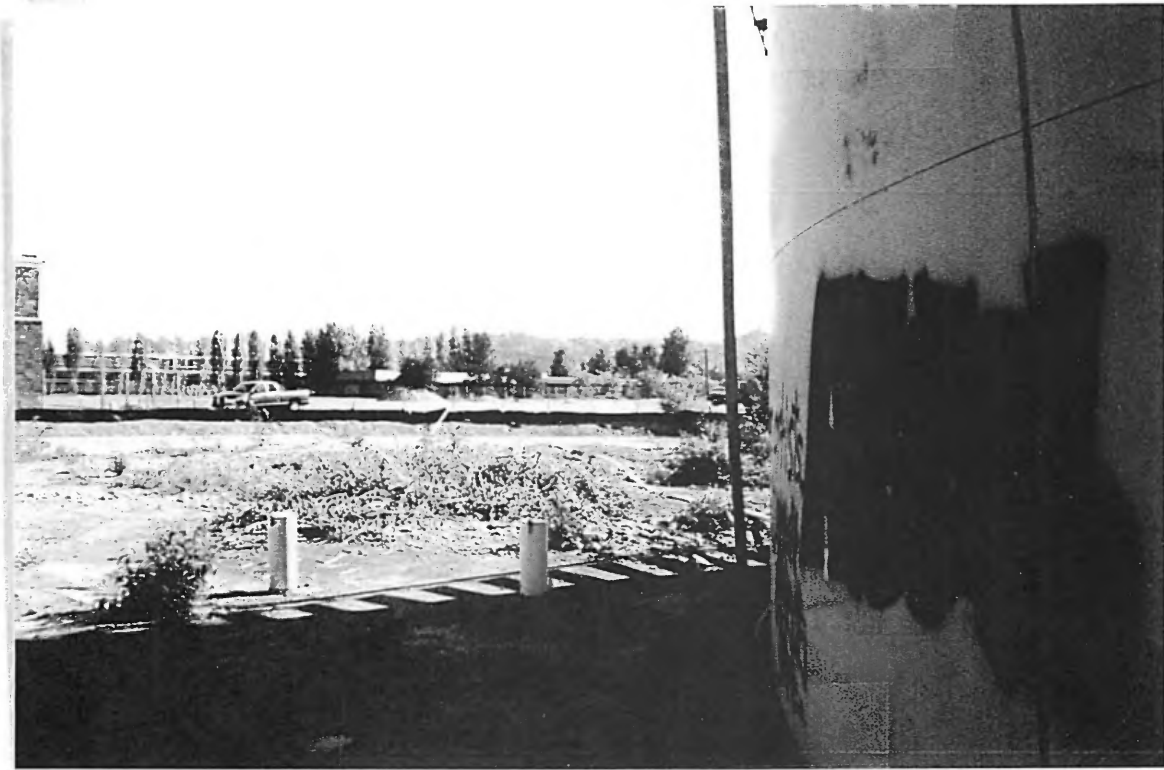
3. Flexhouse going up and into above ground storage tank.

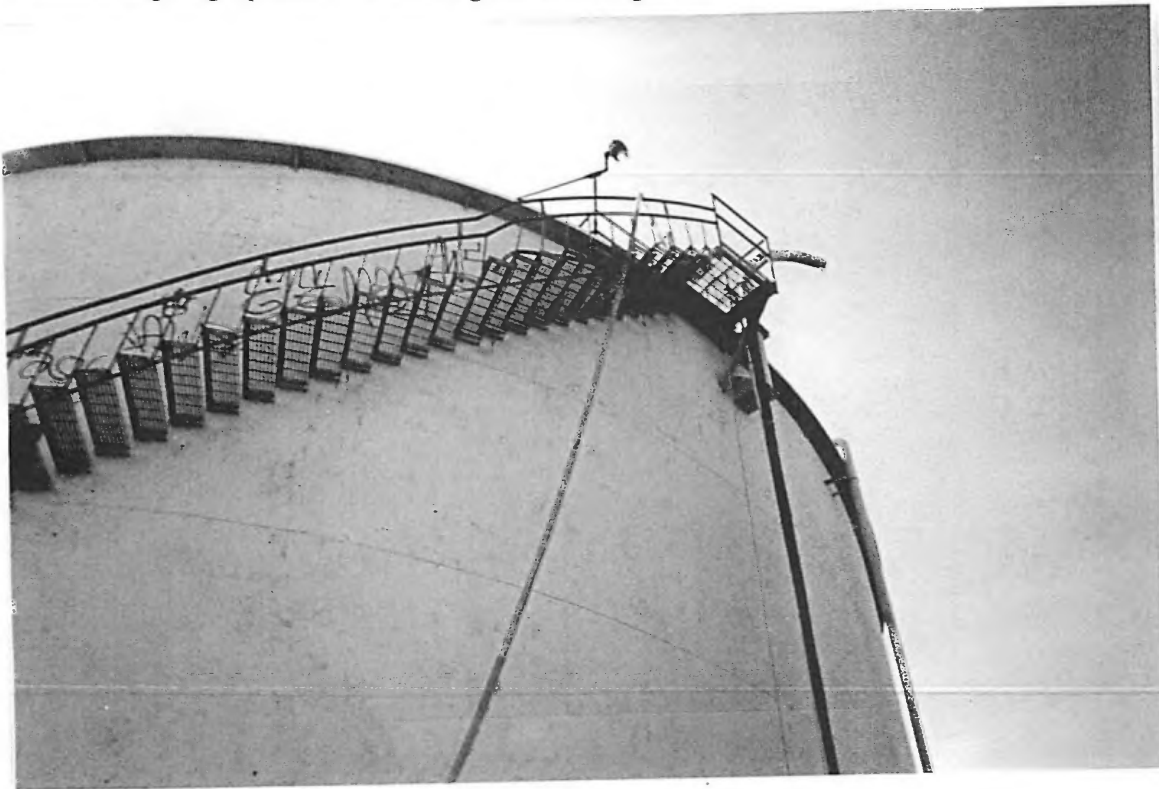
Photo 4. Flexhouse going up and into above ground storage tank.  
Photo taken by Shawn Blocker, U.S. EPA  
8/17/2004

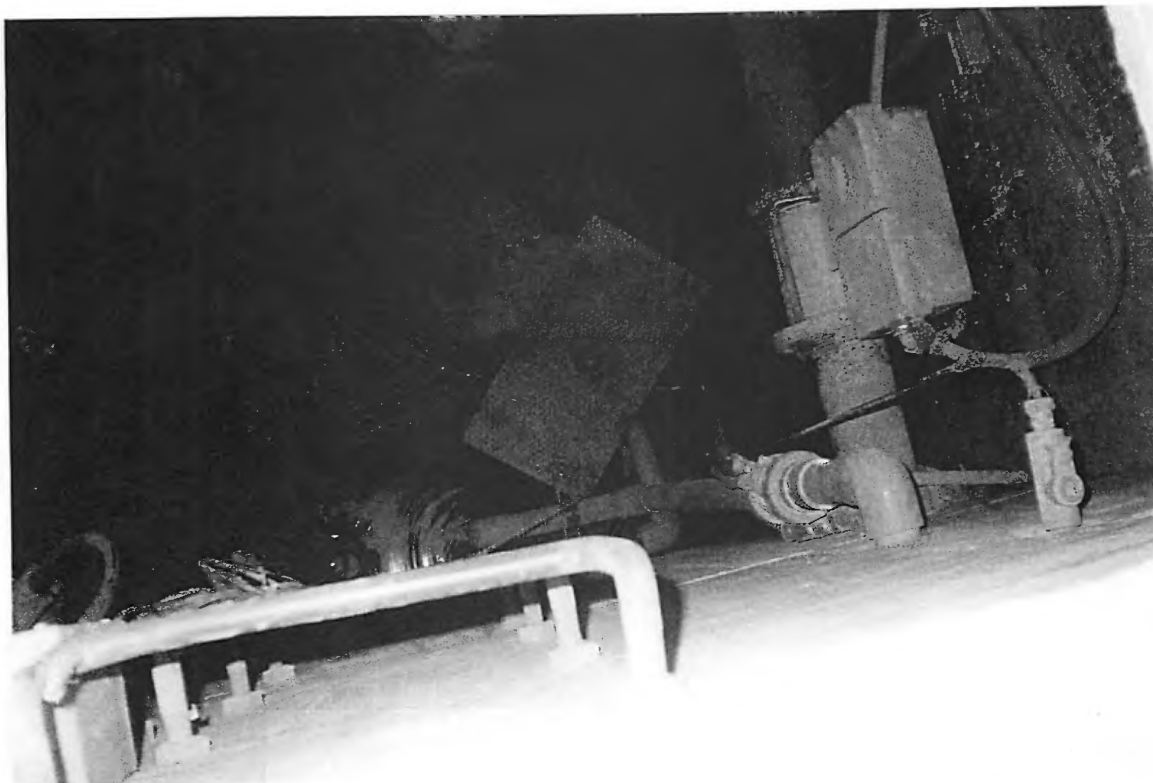
5. Photo inside King County Sewer Lift Station.

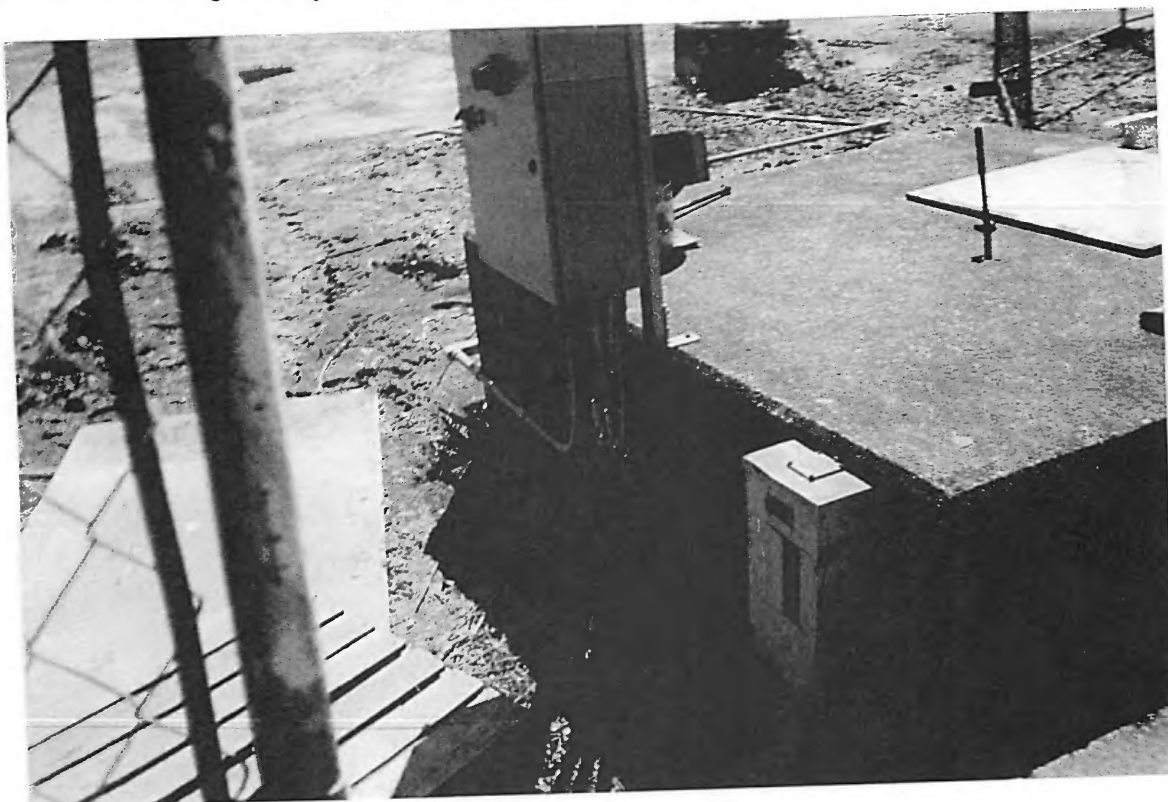
Photo 6. Photo of King County Sewer Lift Station.  
Photo taken by Shawn Blocker, U.S. EPA  
8/17/2004

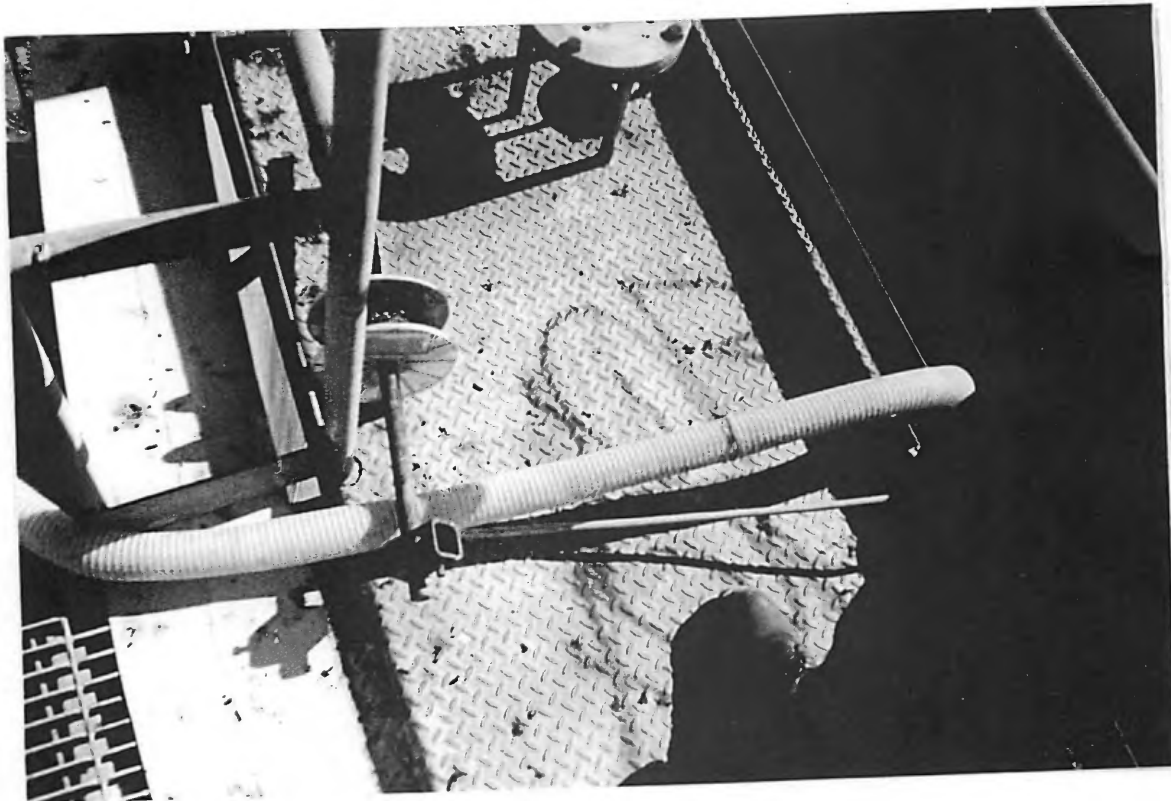
7. Photo of flex hose going into above ground storage tank from the top.

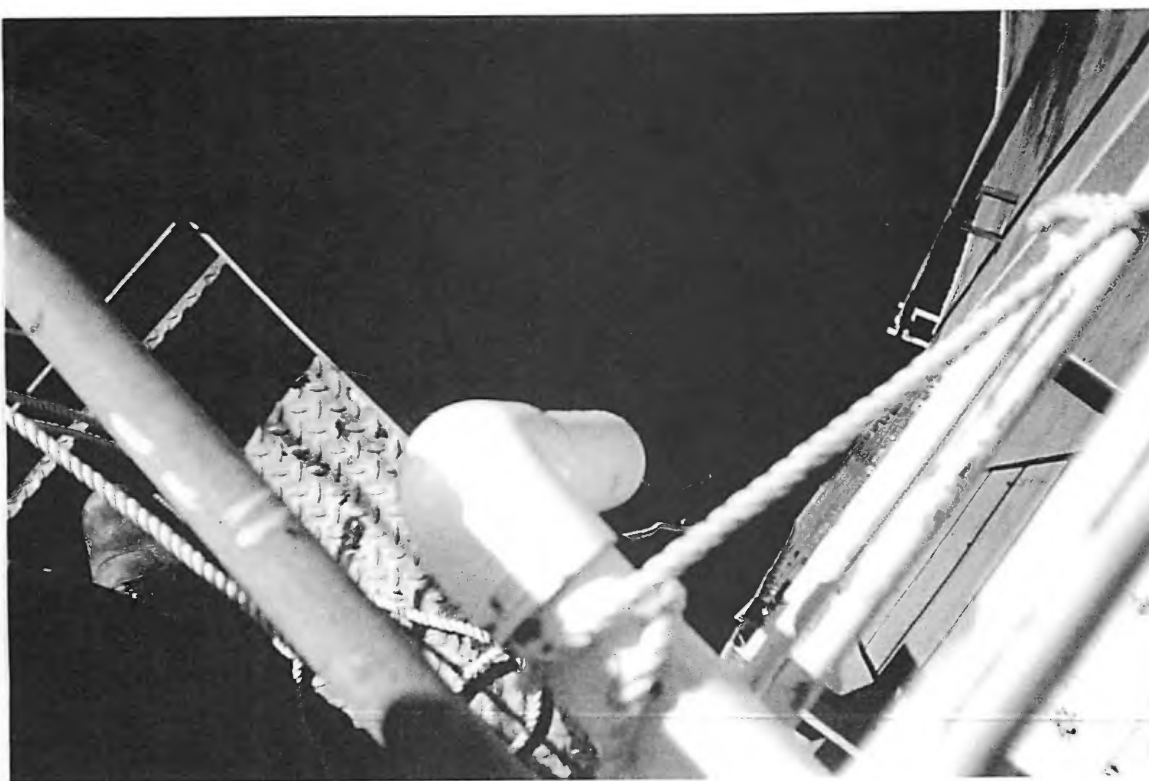
Photo 8. Photo of flex hose going into above ground storage tank from the top..  
Photo taken by Shawn Blocker, U.S. EPA  
8/17/2004

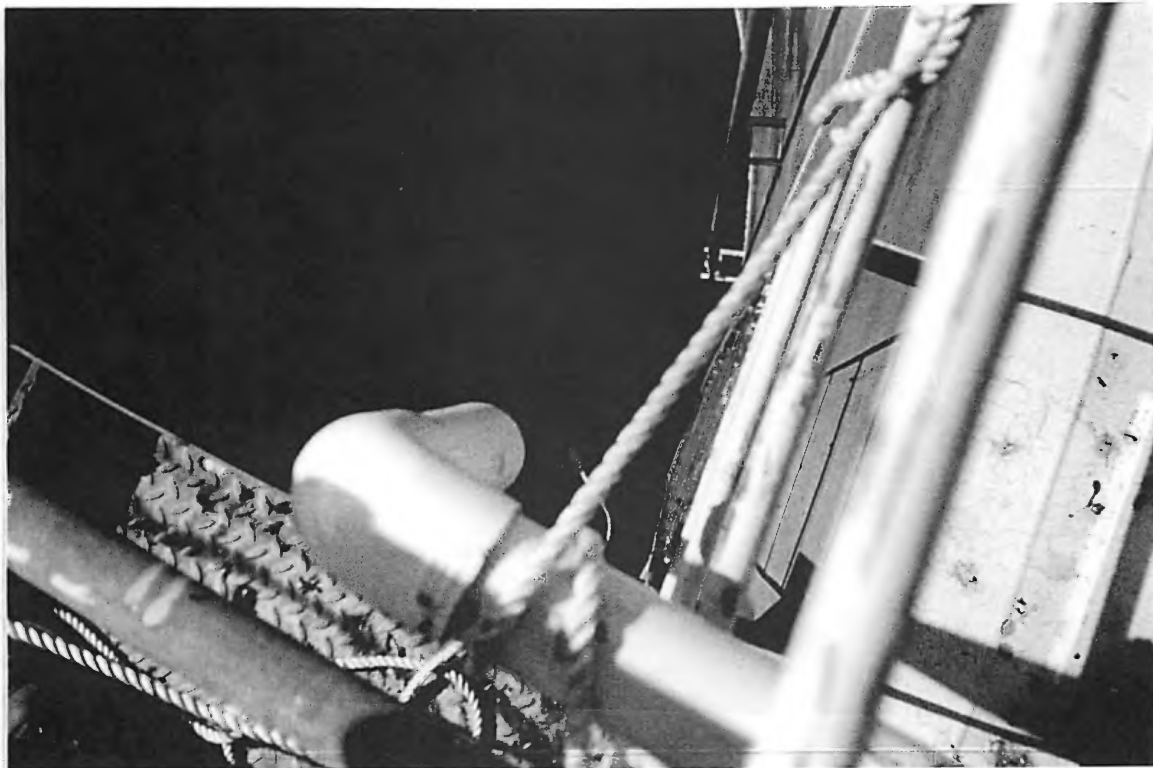
9. Photo of hose going into above ground storage tank from the top.

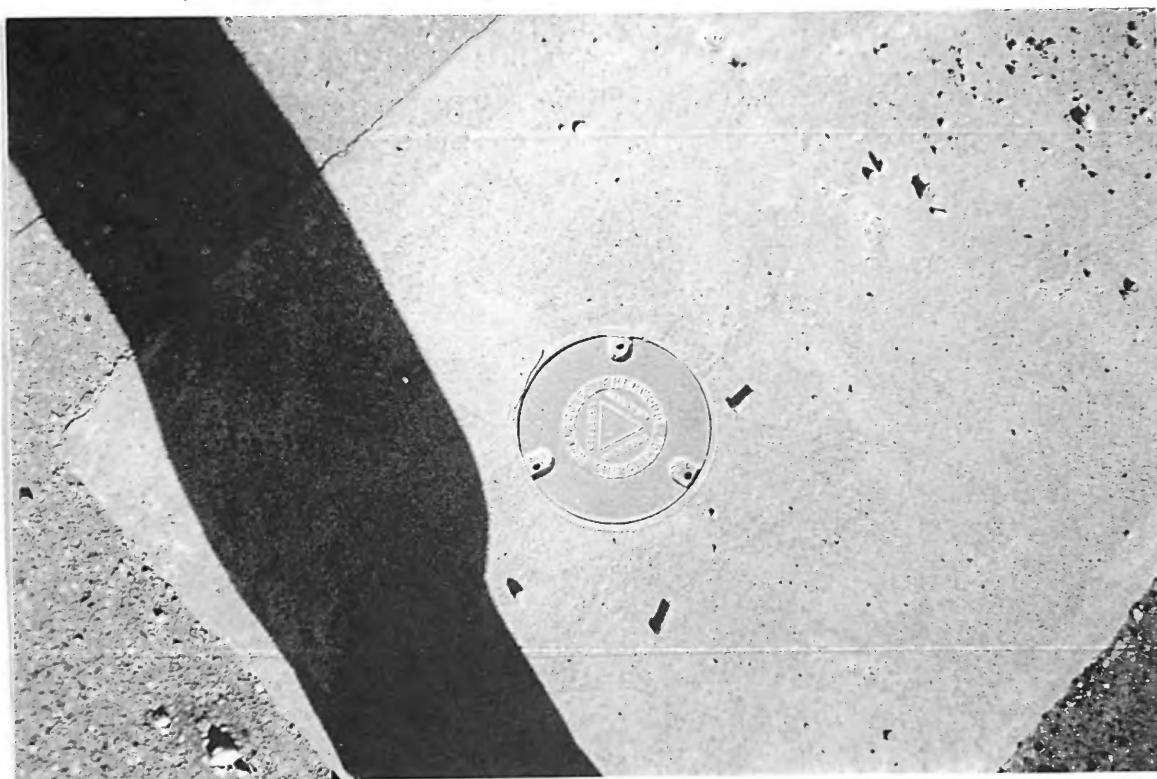
Photo 10. Photo of well cover not properly bolted down.  
Photo taken by Shawn Blocker, U.S. EPA  
8/17/2004

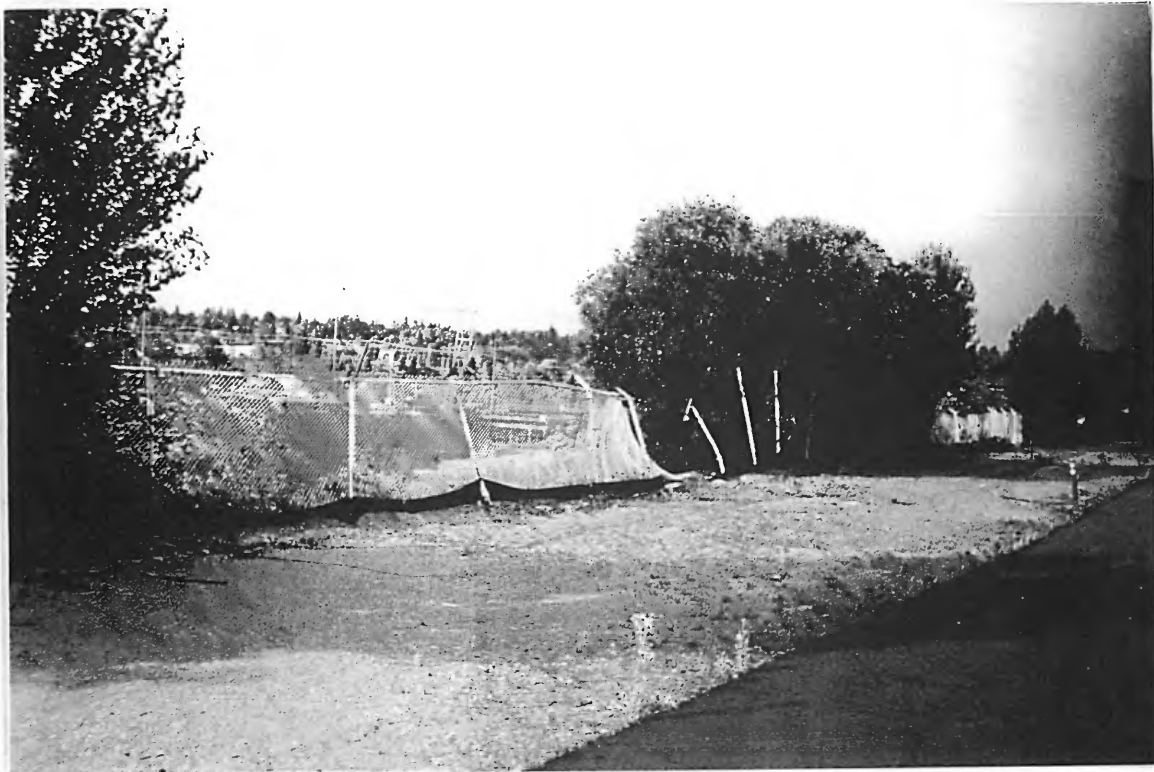
11. Missing fence along slip 6.

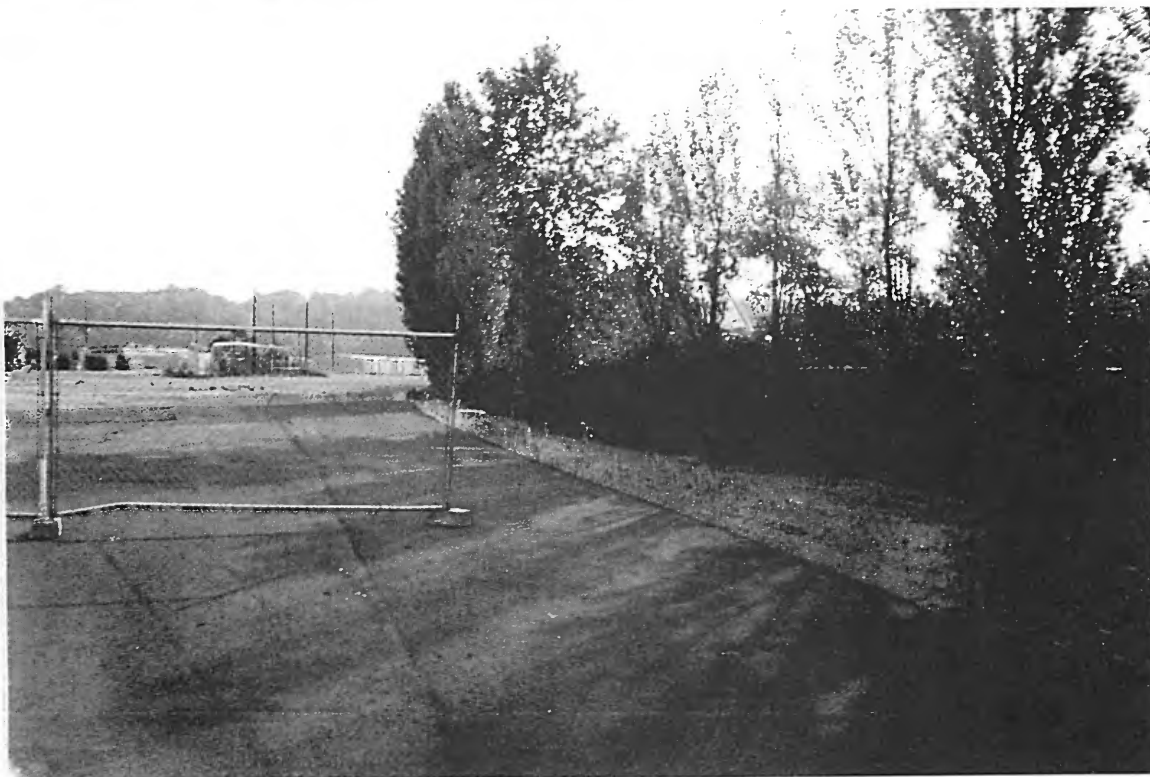
Photo 12. Missing fence in southeast corner of site.  
Photo taken by Shawn Blocker, U.S. EPA  
8/17/2004

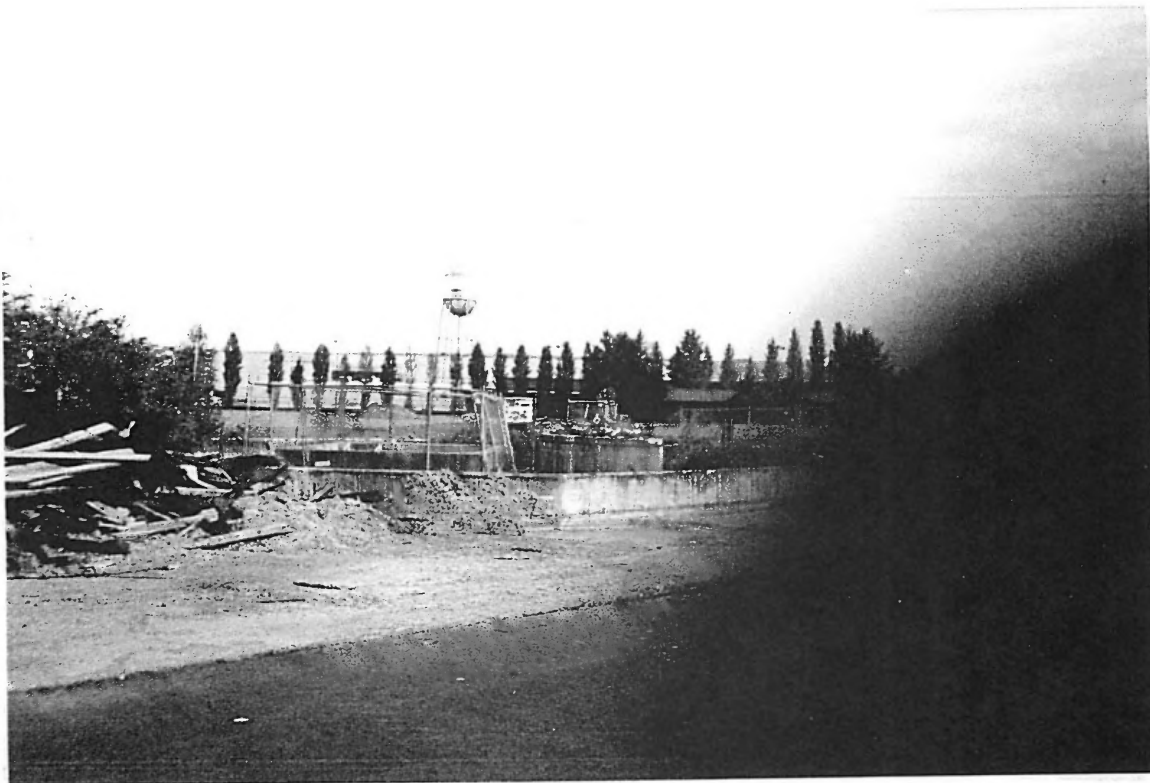
Photo 13. Missing fence near lift station.  
Photo taken by Shawn Blocker, U.S. EPA  
8/17/2004
